# History and present state of the Slano Blato landslide

**Abstract.** The Slano Blato landslide is more than 1290 m long, 60 to 200 m wide and 3 to 11 m deep with a volume of about 700 000 m<sup>3</sup>. It is located in the Eocene flysch region of western Slovenia with a limestone overthrust in the direct vicinity, above the landslide. The landslide moves mainly as a viscous earth flow with occurrences of rapid mud flows. In dry periods or in freezing conditions it behaves as a group of several slow to moderate landslides. The landslide follows the course of the Grajšček stream and is presently only 220 m away from Lokavec village. The landslide was first mentioned about 200 years ago. In 1887 it flowed as a liquid flow and reached and destroyed the main road in the valley 2 km away. The Austro-Hungarian monarchy sent one engineer to the site and 17 years later the slide was remediated with a series of torrential check dams. The monarchy prohibited any construction works in the influence area of the landslide. During the 20th century the region changed from Austrian, Italian, Yugoslav, and finally to Slovenian government in 1991. The relevant Austrian measures and decisions were

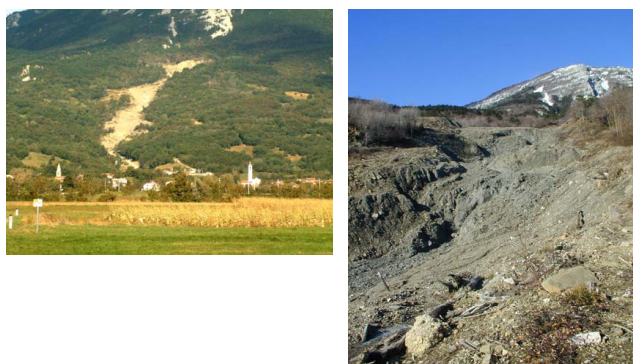
**Fig. 4.** A far and a close view of the Slano Blato landslide.

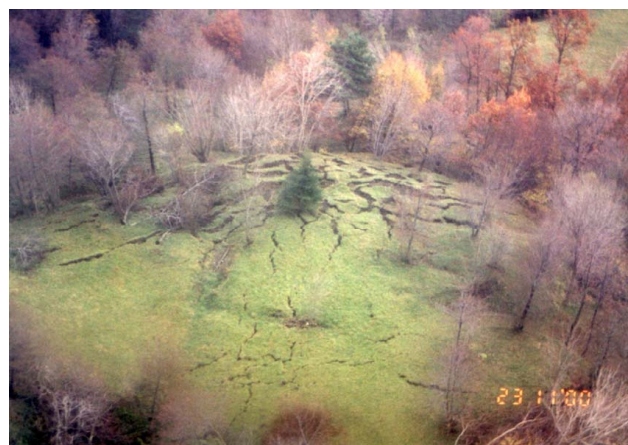
**Fig. 5.** The photo taken on 23 November 2000, at the location later on referred to as the “Lake of Mud” just before the vegetation was ripped off. Note the pronounced heave in the centre due to the pressure caused by the soil sliding.

the ground shown in Fig. 5, indicating that the ground became soft due to the water emerging from the bedrock and not from the surface) it was suggested that an important influx of water to the sliding mass came also from the lower flysch layers. Later on this was confirmed when the first two large hollow concrete shafts with a diameter of 5 m were made as a part of remediation actions. Up to  $15 \text{ m}^3$  of water per day can be collected in one shaft.

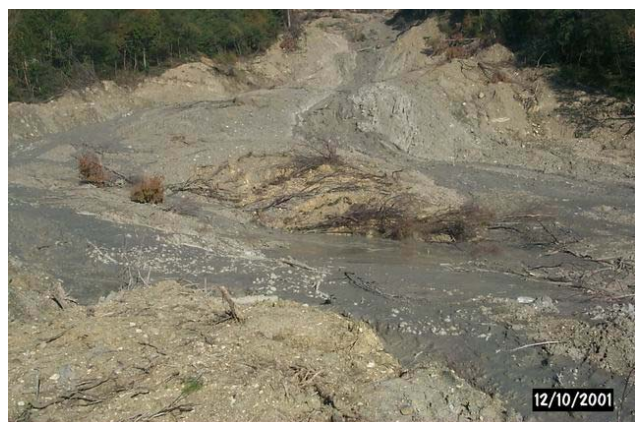
**Fig. 7.** Several minor mudflows occurred in October 2001.

4. In October 2001 several minor, very rapid to extremely rapid mudflows (according to Cruden and Varnes, 1996) generated from the lower part of the earth flow and followed the Grajšček stream bed through the village of Lokavec (Fig. 7). The mudflows were different in volume, density, and in the rate of advance.

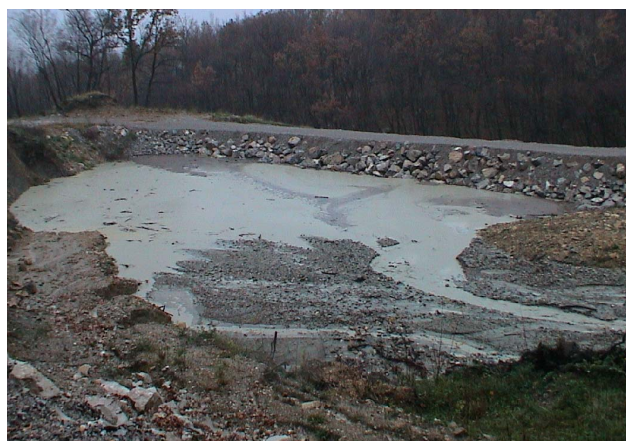
**Fig. 8.** The rockfill dam that can retain up to 5000 m<sup>3</sup> of mud and debris was constructed to protect the village of Lokavec from extremely rapid mud flows generated at the surface of the stopped earth flow masses.

5. At the beginning of 2002 a small rockfill dam with a bottom outlet was constructed in the Grajšček stream bed some 280 m from the village of Lokavec to protect it against the potential mudflows. Up to 5000 m<sup>3</sup> of debris could be retained behind the dam (Fig. 8). During the autumn and winter 2001–2002, up to 200 000 m<sup>3</sup> of mud and debris were mechanically removed from the area of the front of the earth flow and deposited on a dumping site in the valley bottom outside the village of Lokavec. The aim of this remediation measure was to protect the rockfill dam and the village of Lokavec

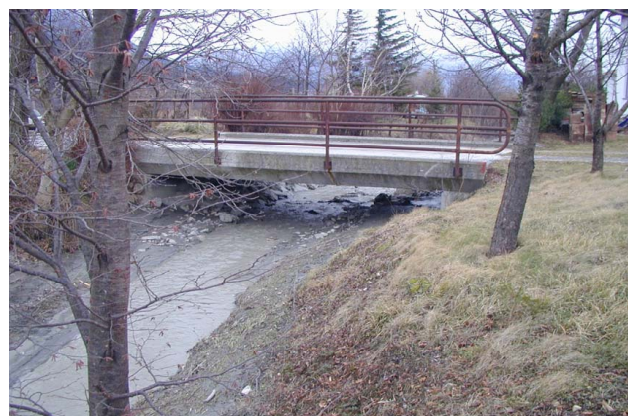
**Fig. 21.** The area of Grajšček stream cross-section under the bridge is important for the flood and mudflow safety and therefore needs constant maintenance. The photo shows the cross-section partly filled with mud, which needs intervention.

- Several drainage trenches in the upper part of the landslide were put in function in 2002, and were destroyed in 2003 due to retrogressive sliding. They were rebuilt in 2004,
- Removal of 200 000 m<sup>3</sup> of the earth flow masses in the area of its front, for which a remediation of the local road was necessary,
- A small rockfill dam against fast mudflows,
- The Grajšček streambed was enlarged, made concave and protected by rip-rap to withstand fast flowing mudflows (Fig. 21).
